# STUDY ON THE FACTORS PROMOTING THE OCCURRENCE OF FISH-BONING ON HDG STEEL AND HOW TO PREVENT ITS FORMATION

Éric Michaud  
2026-10-08

AGA Tech Forum / Denver, CO

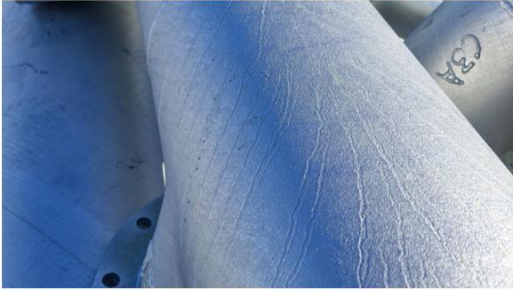
Close up of "fishboning" on abrasive blasted and hot-dip galvanised pipes.

However, it was actually this sandblasting that caused the fish-boning problem to appear.

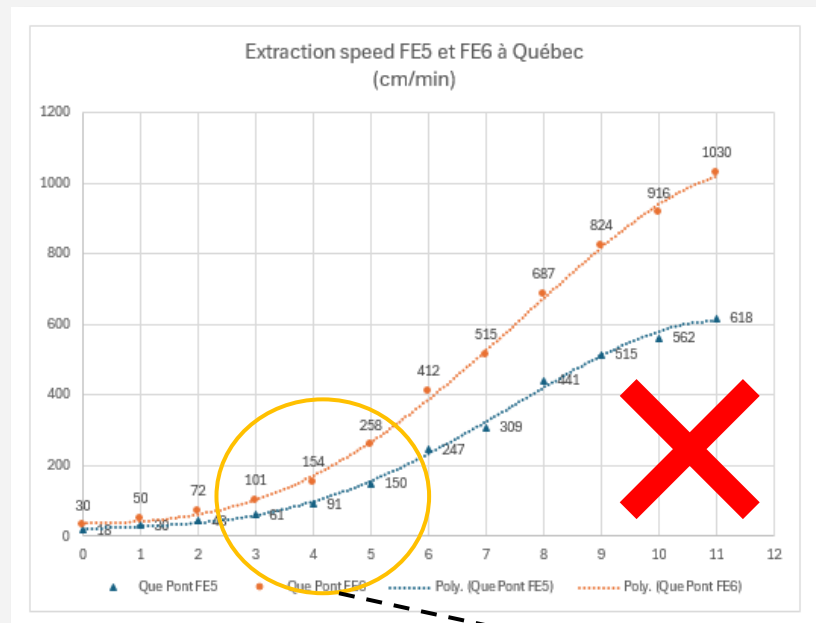
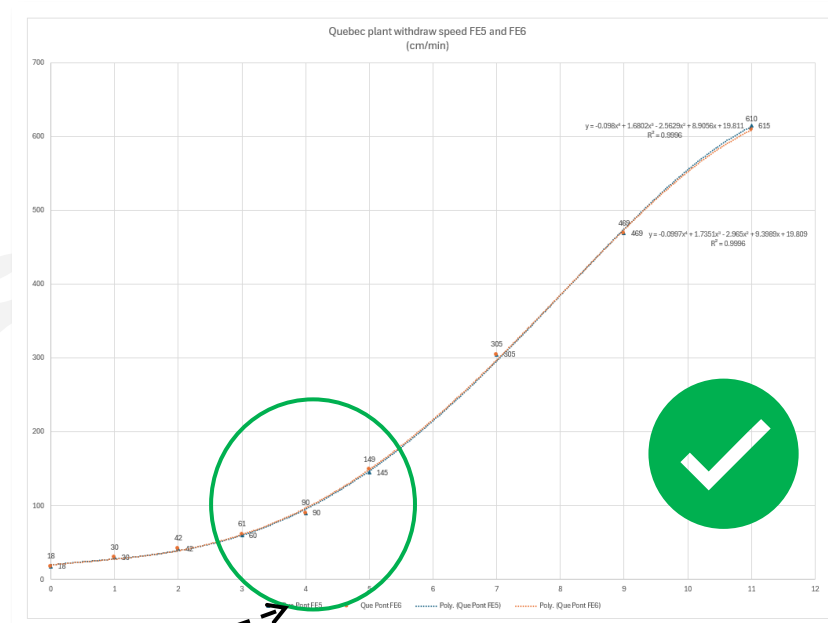
FE5 and FE6 **before** calibration

We looked at the extraction speed of the monorail crains (2 sets) used at the kettle.

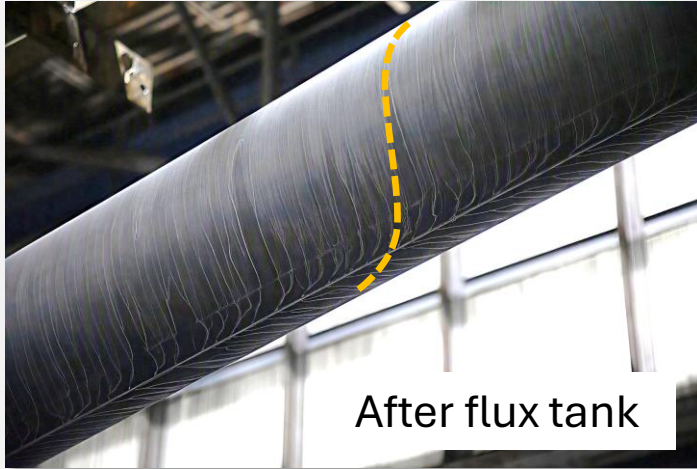
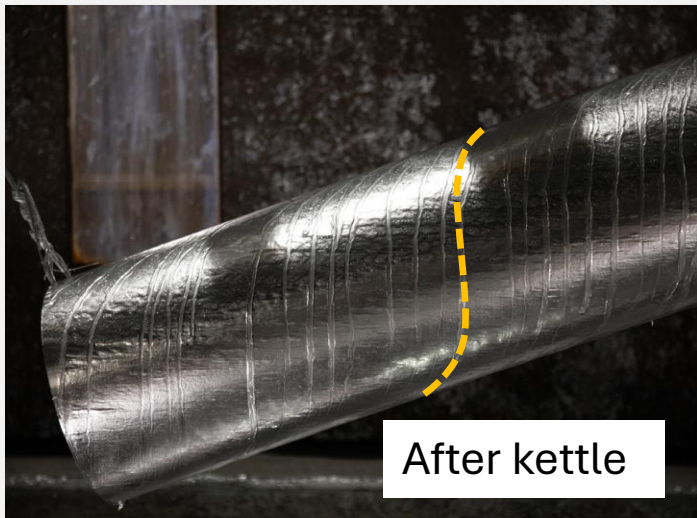
Similarities in the liquid flow pattern observed on the tube as it exits the flux tank and the galvanizing kettle.

**It suggest that the fish-boning problem could be attributed to a disruption in the zinc flow rather than to differences in steel composition.**

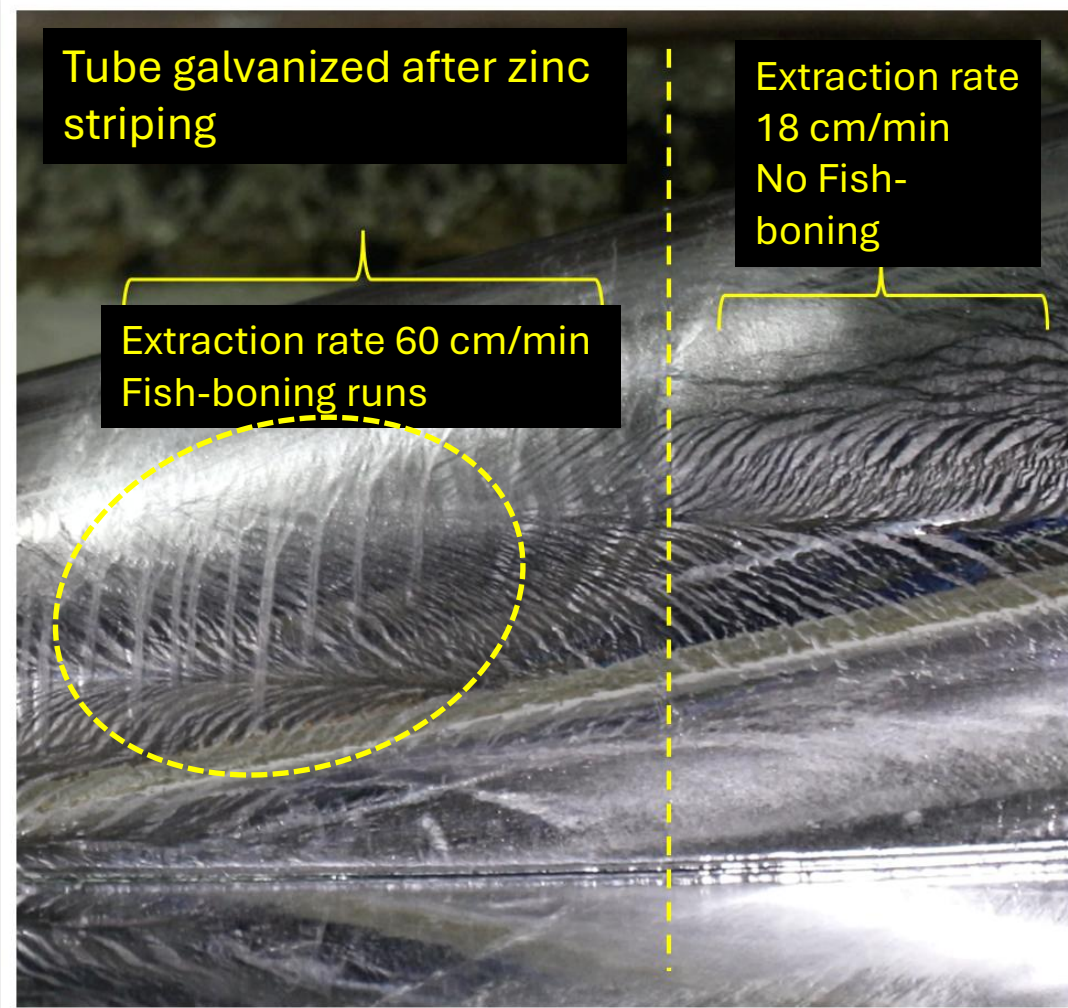
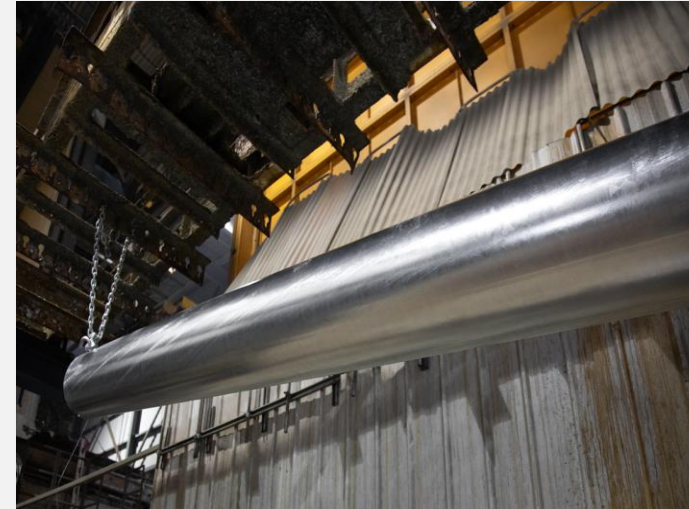
**On the initial galvanization of tubes,** kettle extraction rate from 60 to 150 cm/min (24 to 60 inches/min) is not an issue.

**No fish-boning is observed when using these parameters.**

Once a tube has been stripped, the kettle extraction rate should be as low as possible. **Best results were achieved with a rate in the range of 18 to 30 cm/min (7 to 11 inches/min)**

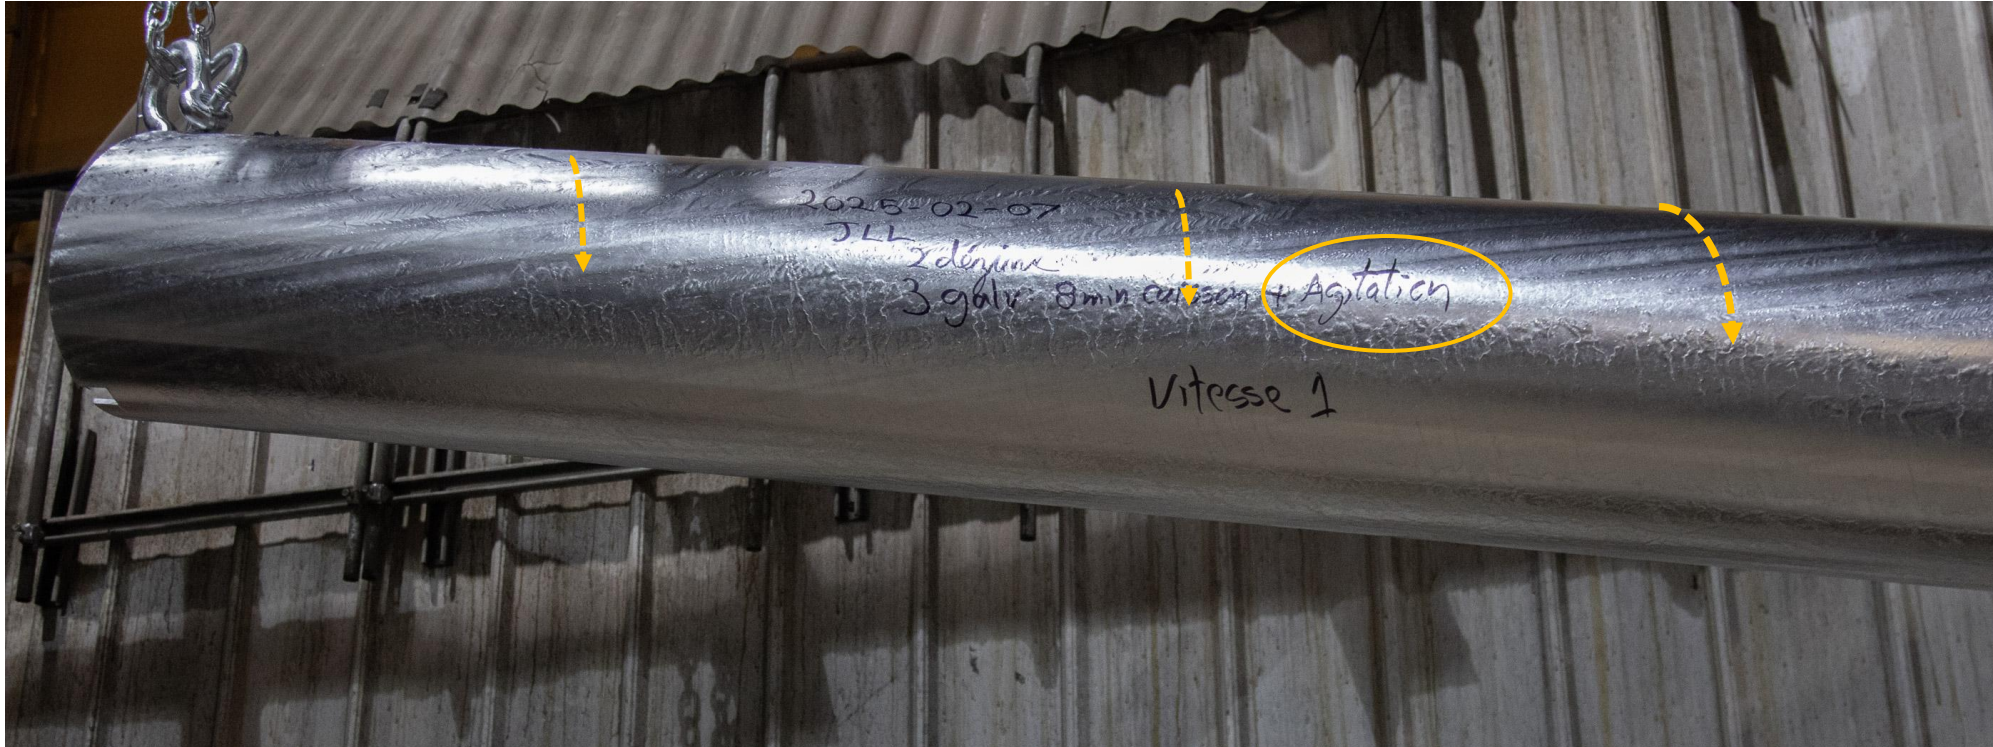
Based on observations, fish-boning resembles a gel on the tube surface. Gentle agitation during dwell time helps to wash this gel away. It seems to glide along the tube wall (see picture above).

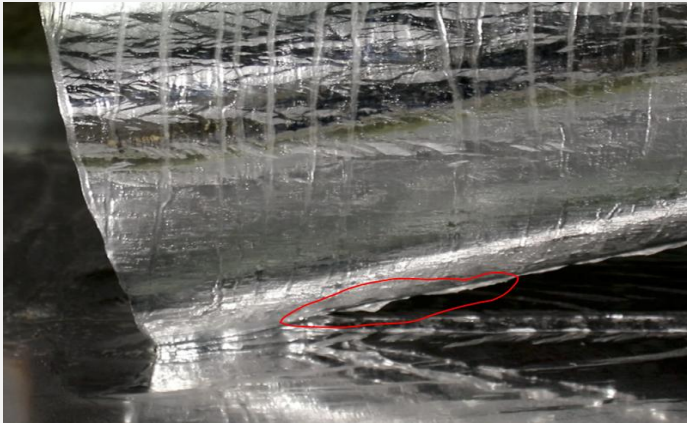
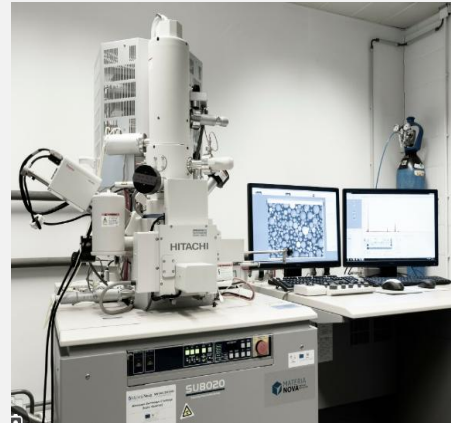
# Fortunately, during the experimentation, a sample of viscous zinc flowing along a tube was collected.

The presence of bubbles in the sample indicates the possible presence of gas in the molten zinc at the time of its solidification. ✓

**Which reinforces the hypothesis of  $H_2$  desorption in the kettle is modifying the flow of liquid zinc on the galvanized part and is responsible of fish-boning on tubes.**
