# STUDY ON THE FACTORS PROMOTING THE OCCURRENCE OF FISH-BONING ON HDG STEEL AND HOW TO PREVENT ITS FORMATION

Éric Michaud  
2026-10-08

AGA Tech Forum / Denver, CO

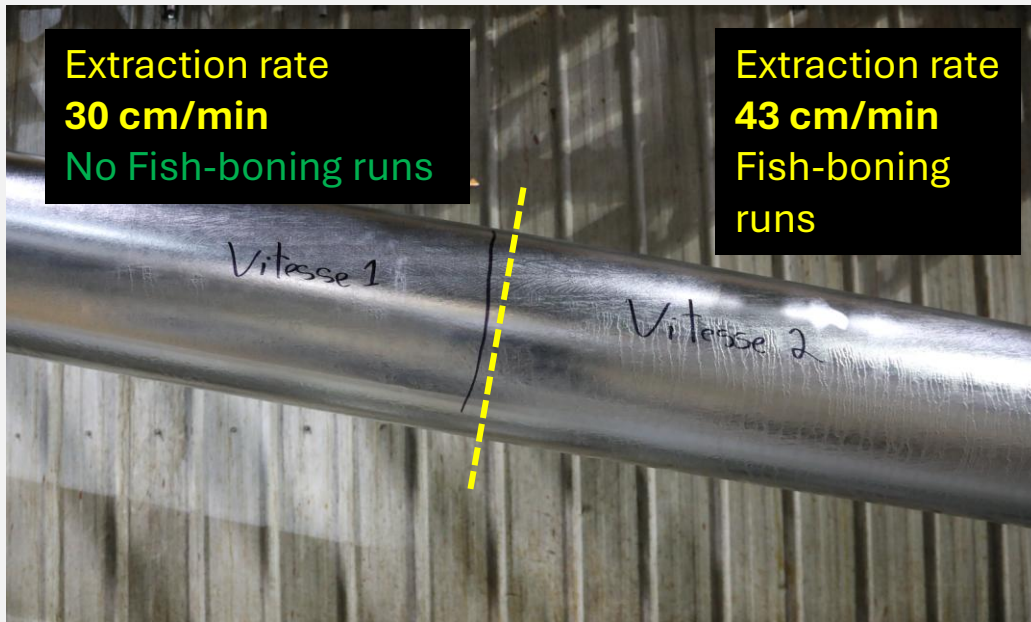
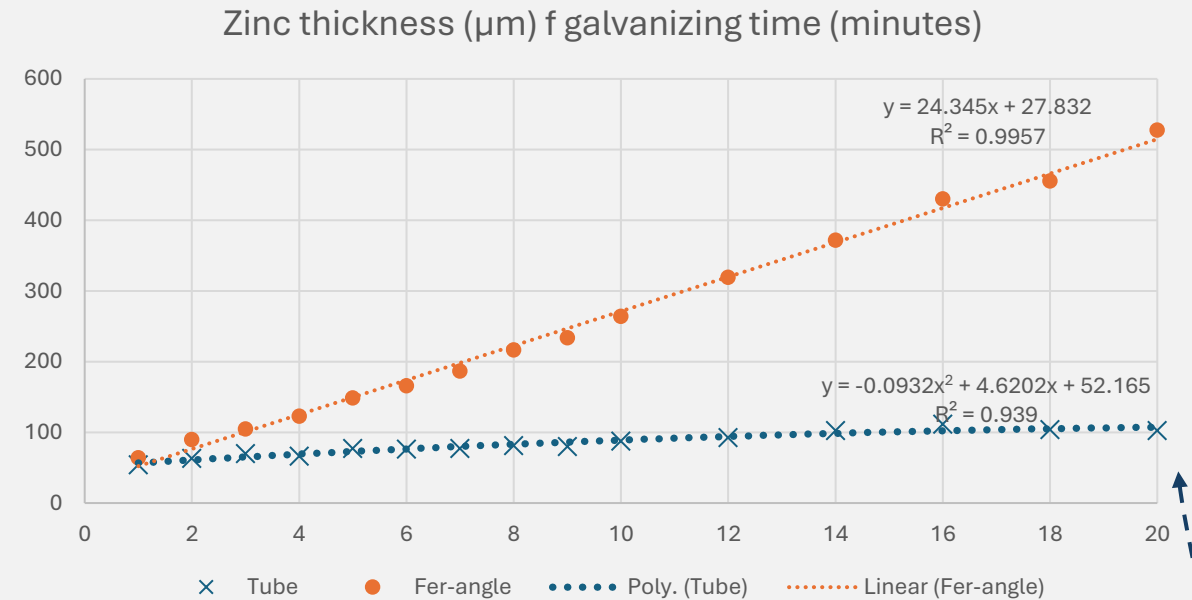
# Kettle extraction rate

**Slow extraction rates mean longer time in the kettle.**

Once a tube has been stripped, the kettle extraction rate should be as low as possible. **Best results were achieved with a rate in the range of 18 to 30 cm/min (7 to 11 inches/min)**

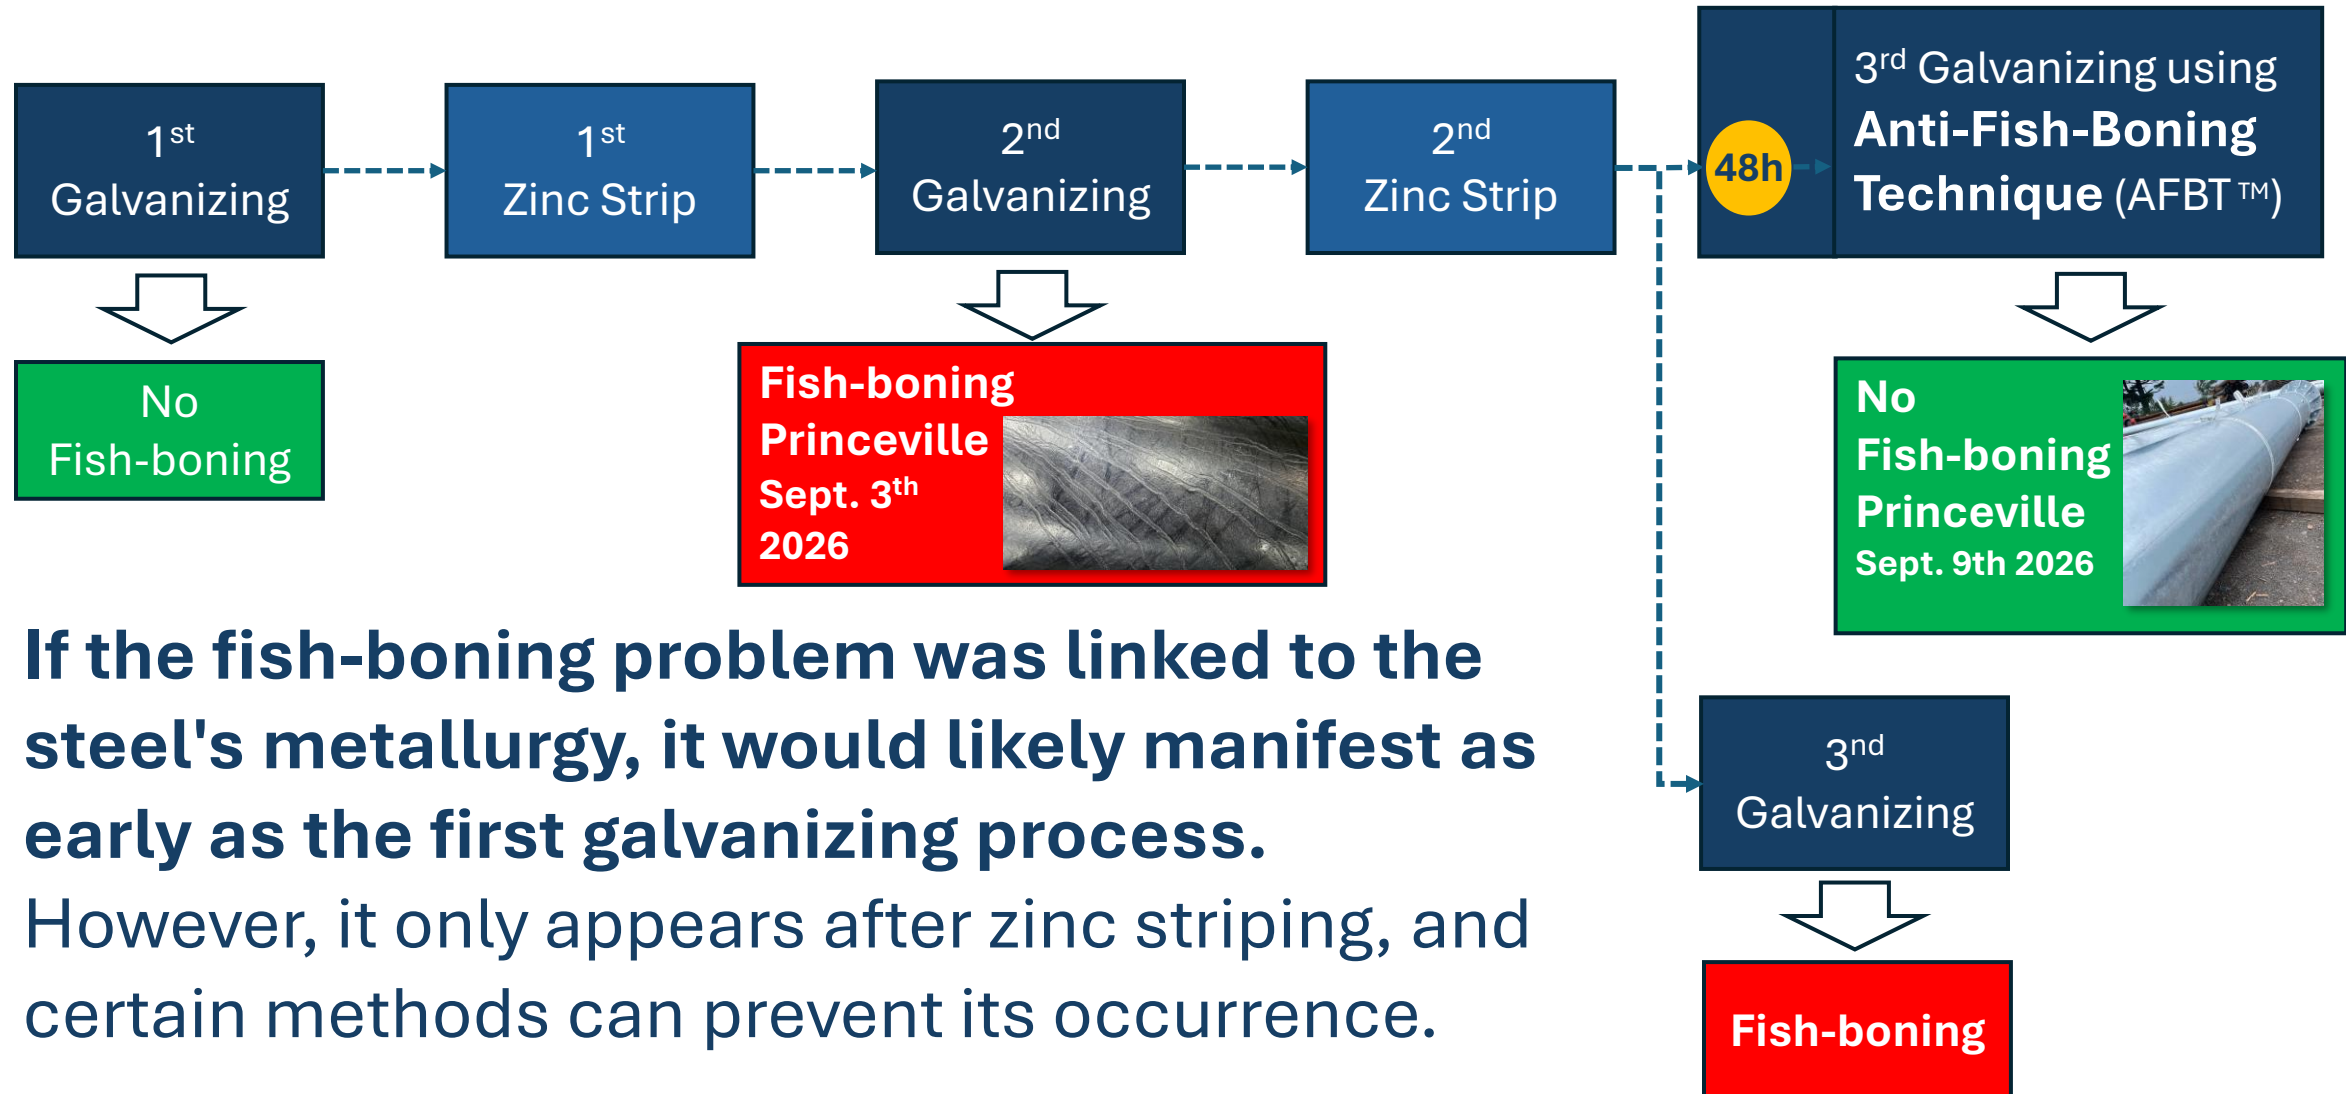
# Quebec fish-boning case: Observations

If the fish-boning problem was linked to the steel's metallurgy, it would likely manifest as early as the first galvanizing process.

However, it only appears after zinc striping, and certain methods can prevent its occurrence.

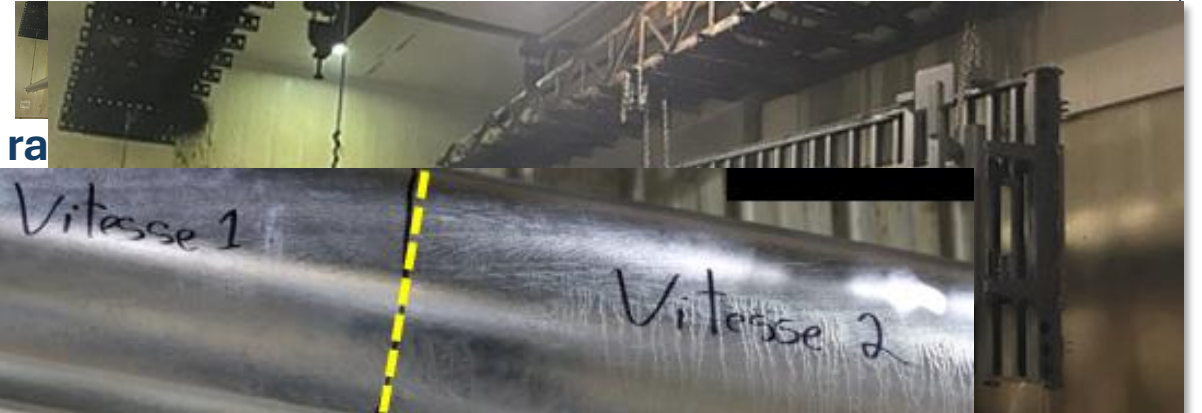
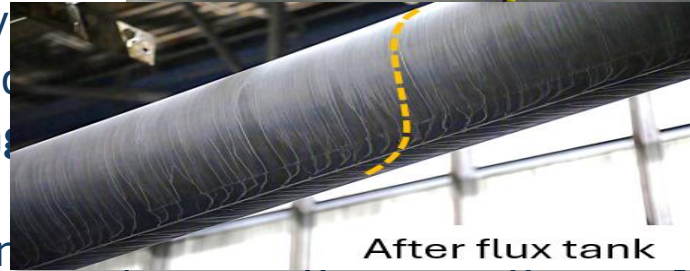
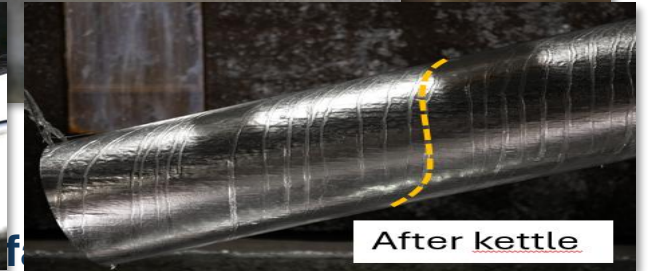
**Fish-boning appears only after zinc stripping.** It mostly appears on tubular shapes but can also be seen on large structures.

Once stripped, the tubes galvanized a second time. And **this time without fish-boning**

**A 48 hours break** between zinc stripping and galvanization helps reduce fish-boning formation.

Up and down agitation in the kettle helps reduce fish-boning.

- **48 hours break after zinc stripping** before regalvanizing.
- **Angle during kettle extraction** is important (Racking the part with a low angle allows a larger amplitude during agitation.) Then the angle is created with the crain.
- **Up and down agitation** during cooking
- Kettle **extraction rate 18 to 30 cm/minute**
- Cooking time 4-8 minutes

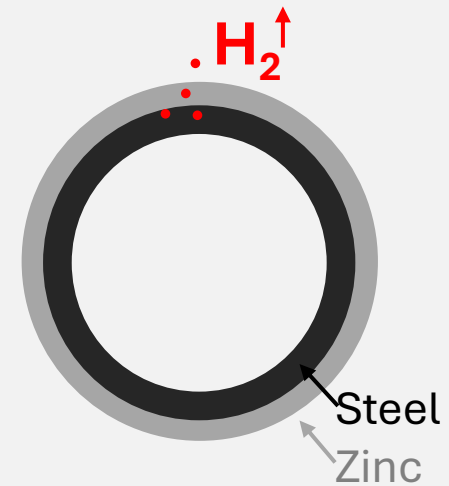
**The hypothesis is that hydrogen gas generated during stripping is absorbed by steel and release while in the kettle.**

The presence of this gas at the steel to liquid zinc interface modifies the flow properties of liquid zinc and contribute to the fish-boning appearance.

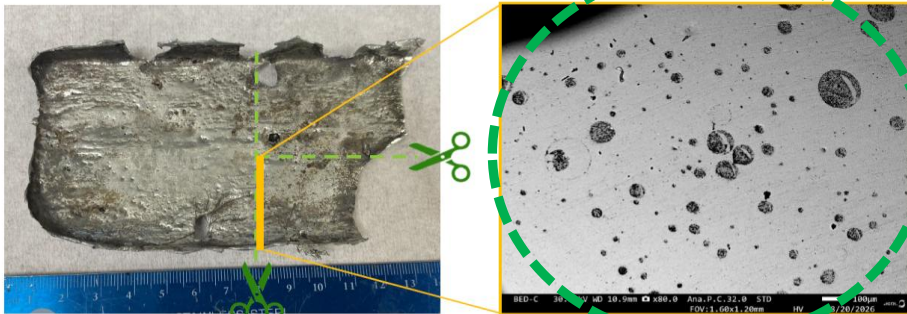
Images de référence de la section transversale

The presence of bubbles in the sample indicates the possible presence of gas in the molten zinc at the time of its solidification. ✓

L'échantillon a été coupé et poli afin de caractériser sa section transversale.
